PRELIMINARY NONDESTRUCTIVE EVALUATION MANUAL FOR THE SPACE SHUTTLE

**PRELIMINARY NONDESTRUCTIVE EVALUATION MANUAL
FOR THE SPACE SHUTTLE**

APPENDIX TO FINAL REPORT

**LOCKHEED-GEORGIA COMPANY
A DIVISION OF LOCKHEED AIRCRAFT CORPORATION
MARIETTA, GEORGIA 30063**

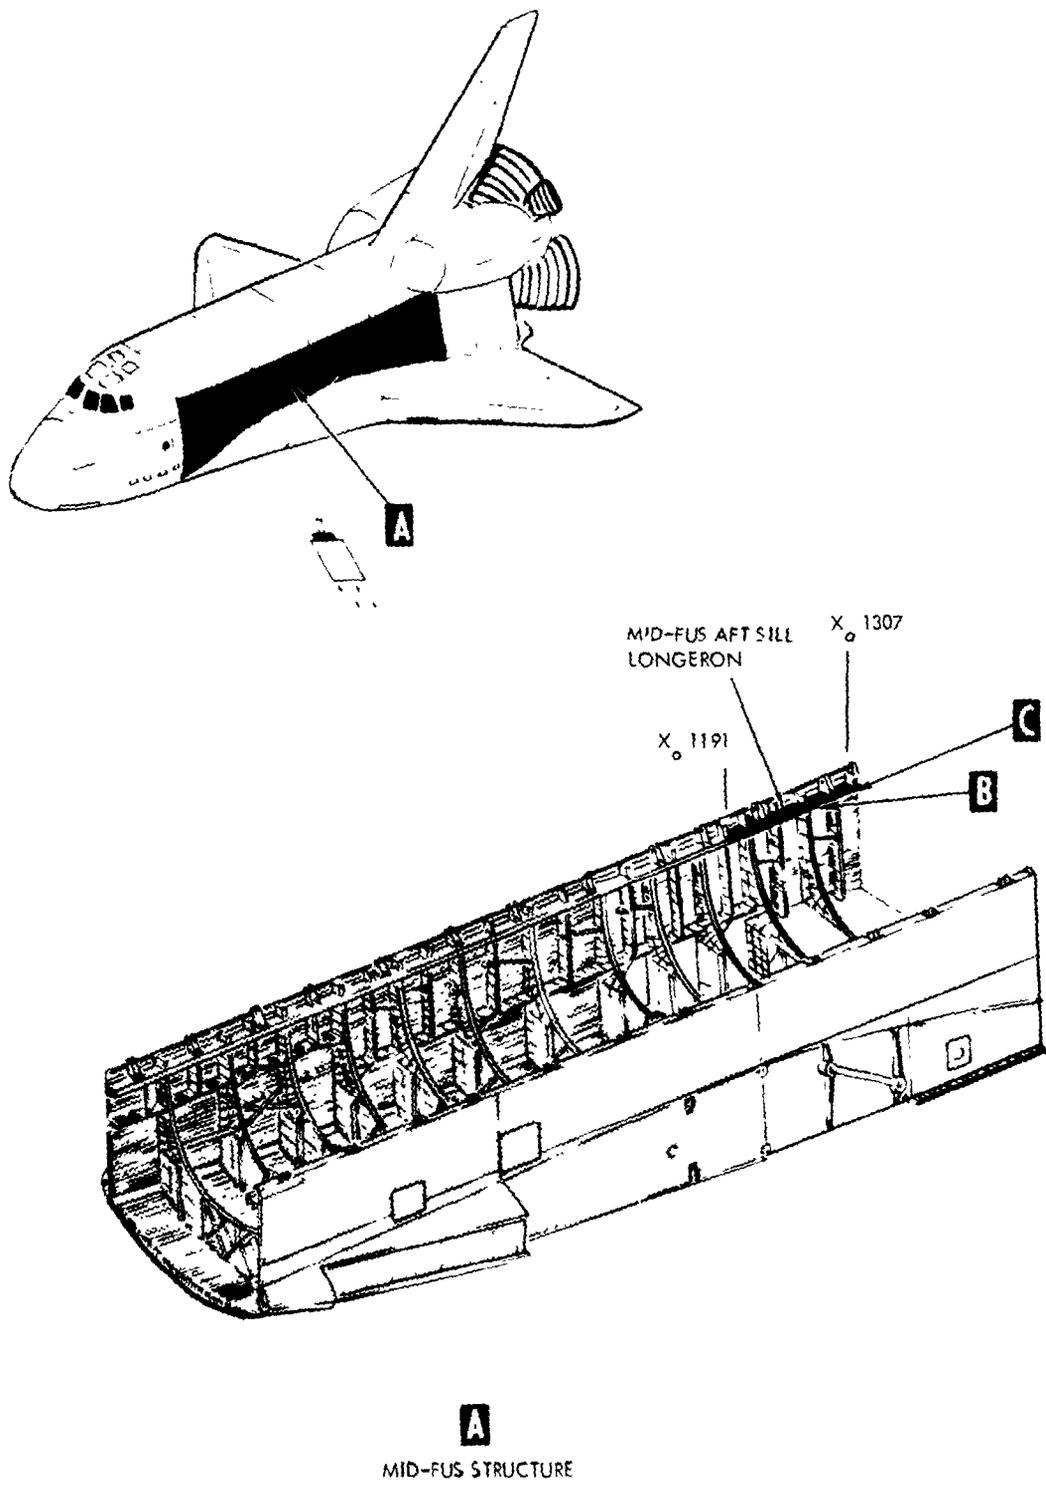
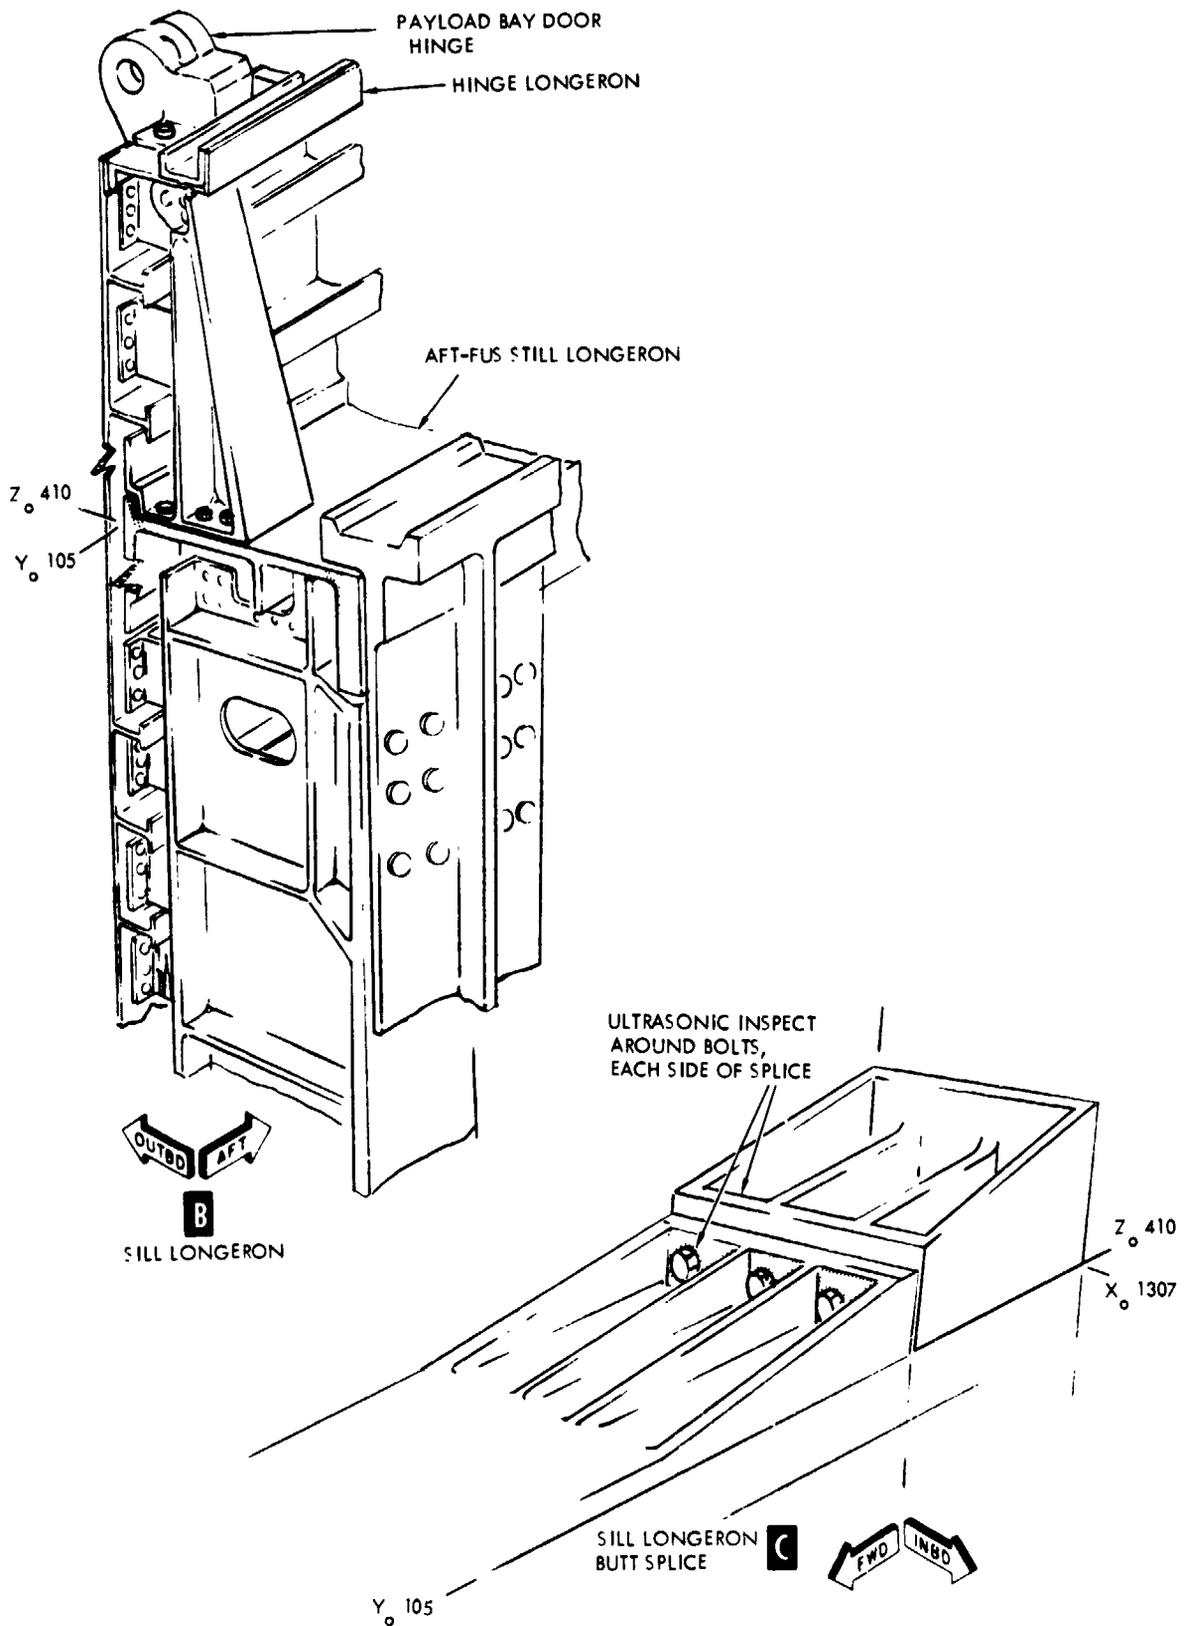
Figure 3-15. Payload Bay Aft Sill Longeron (Sheet 1 of 2)

DEFECTS: Horizontal cracks around bolt holes in longeron-to-aft fus splice at $X_{\circ} 1299$; cracks in fastener holes at fwd splice at $X_{\circ} 1191$.

NDT TECHNIQUES: Primary: Ultrasonic shear wave (para. 1.5.5.3 C)
Backup: Eddy current bolt hole (para. 1.5.4.3) with suspect bolt removed.

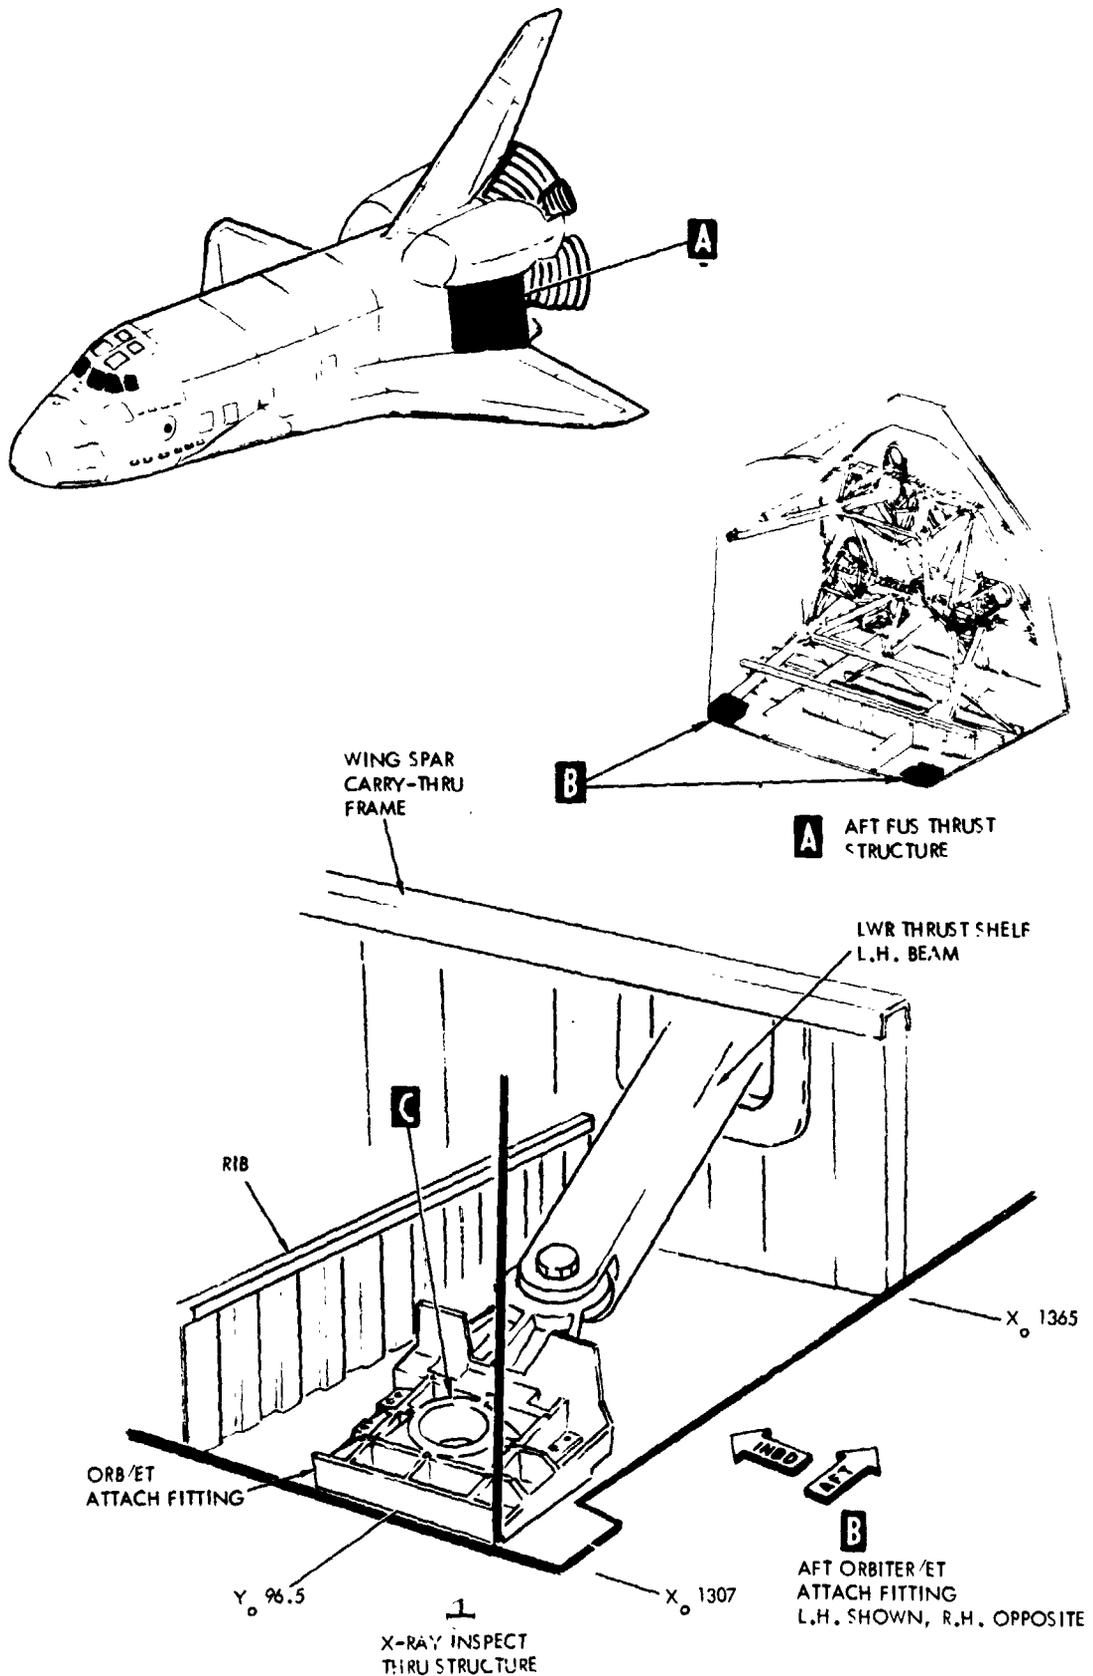
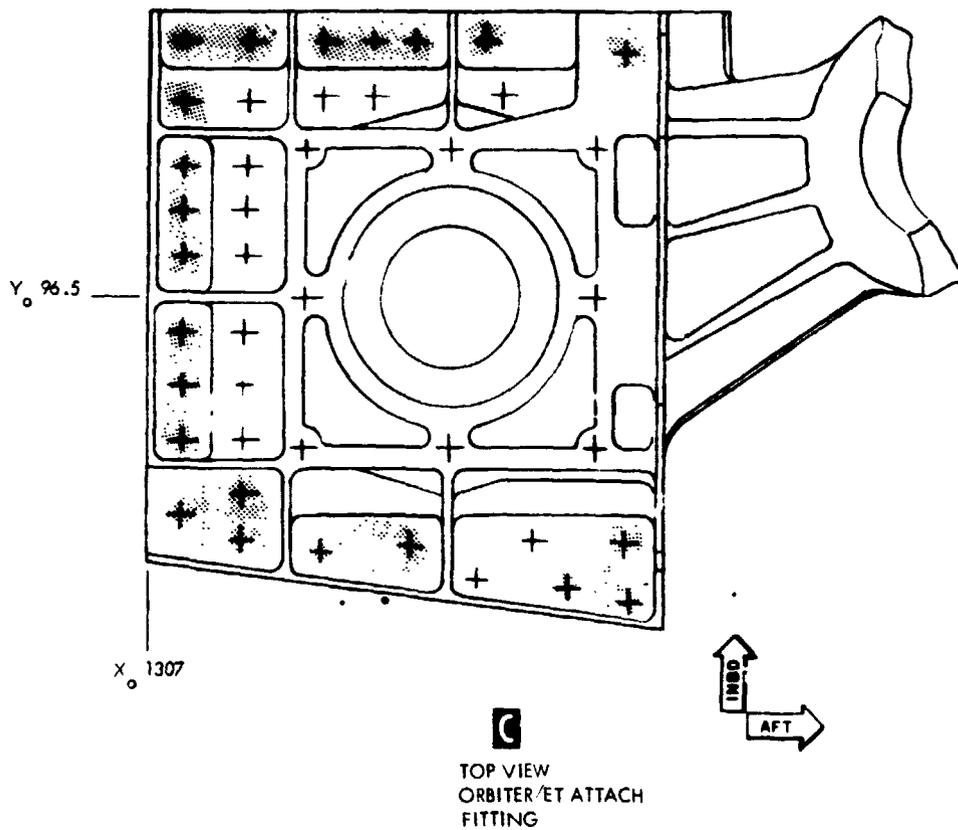
Figure 4-1. Aft ET/Orbiter Attach Fitting (Sheet 1 of 2)

DEFECTS: Cracks may develop from fatigue, overstress or adverse conditions around bolt holes in the base of the fitting where attachments are made to aft-fus floor structure, $X_{\circ} 1307$ bulkhead and floor longeron.

NDT TECHNIQUES: Primary: Radiography (para. 1.5.6.2) for the built-up base/floor structure, ultrasonic shear wave (para. 1.5.5.3 B & C) for additional coverage of fitting base around fastener holes.

ULTRASONIC INSPECT
AROUND FASTENER HOLES

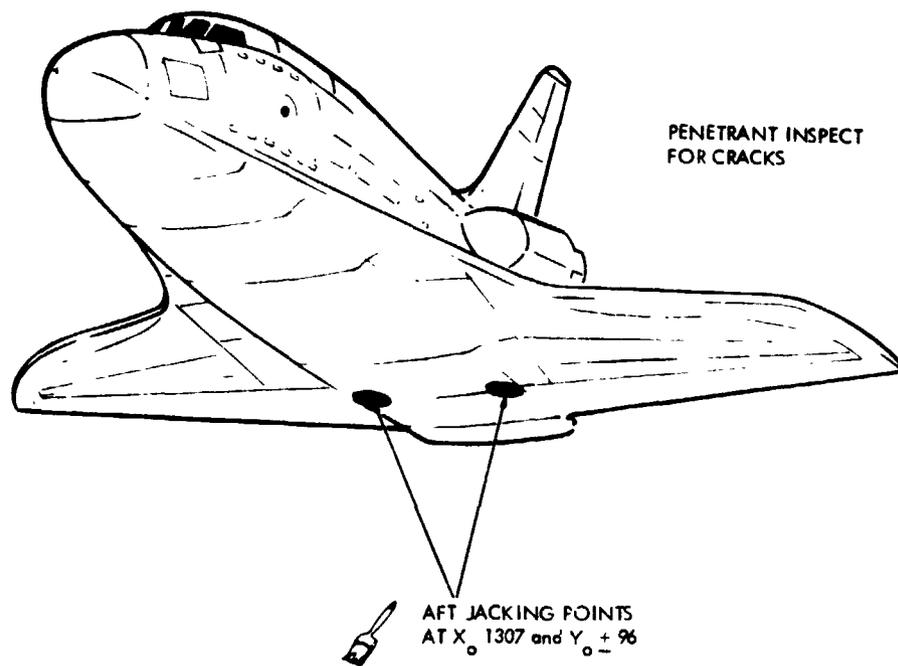
Figure 4-2. Aft Jacking Points

COMPONENT/AREA DESCRIPTION: AFT JACKING POINTS: Two structural hardpoints on the bottom fuselage surface at the X_{\circ} 1307 bulkhead contain jack pad fittings, one each at $Y_{\circ} \pm 96$. These fittings are made of (TBD) and are finished with (finish TBD). The fitting and adjacent structure receive static loads due to the weight of the Orbiter while on jacks. Further, potential brinelling, nicks, and abrasion damage may enhance corrosive attack in a salt-laden atmosphere.

DEFECTS: Cracks may occur in the fitting because of static fatigue or corrosion, and may occur in adjacent airframe structure.

NDT TECHNIQUES: Primary: Fluorescent penetrant (para. 1.5.2.1 Fig. 1-9)
Backup: None required

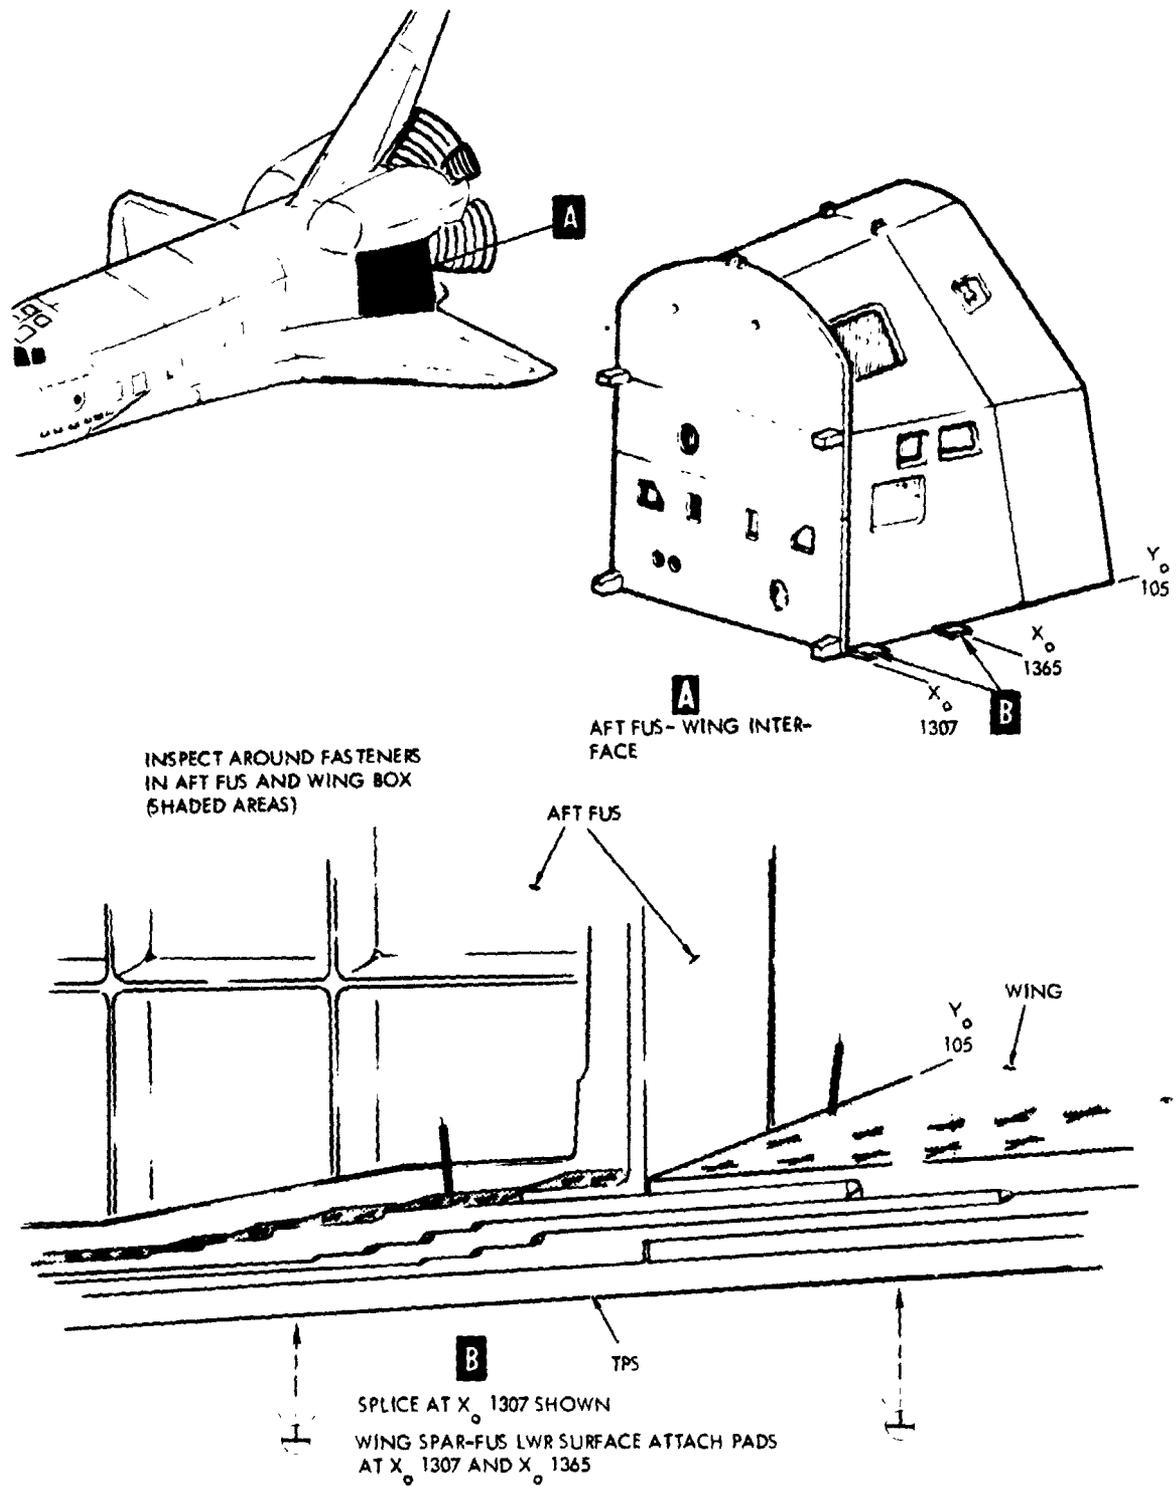
Figure 4-3. Aft-Fuselage/Wing Spar Lower Attach Pads

DEFECTS: Longitudinal cracks radiating from fastener holes in the splice occurring inboard or outboard of the mid-fuselage mold line.

NDT TECHNIQUES: Primary: Radiography (para. 1.5.6.2) for general inspection on either inboard or outboard portions; eddy current surface probe (para. 1.5.4.4) for frame cap or wing splice fitting for special inspections around fasteners.

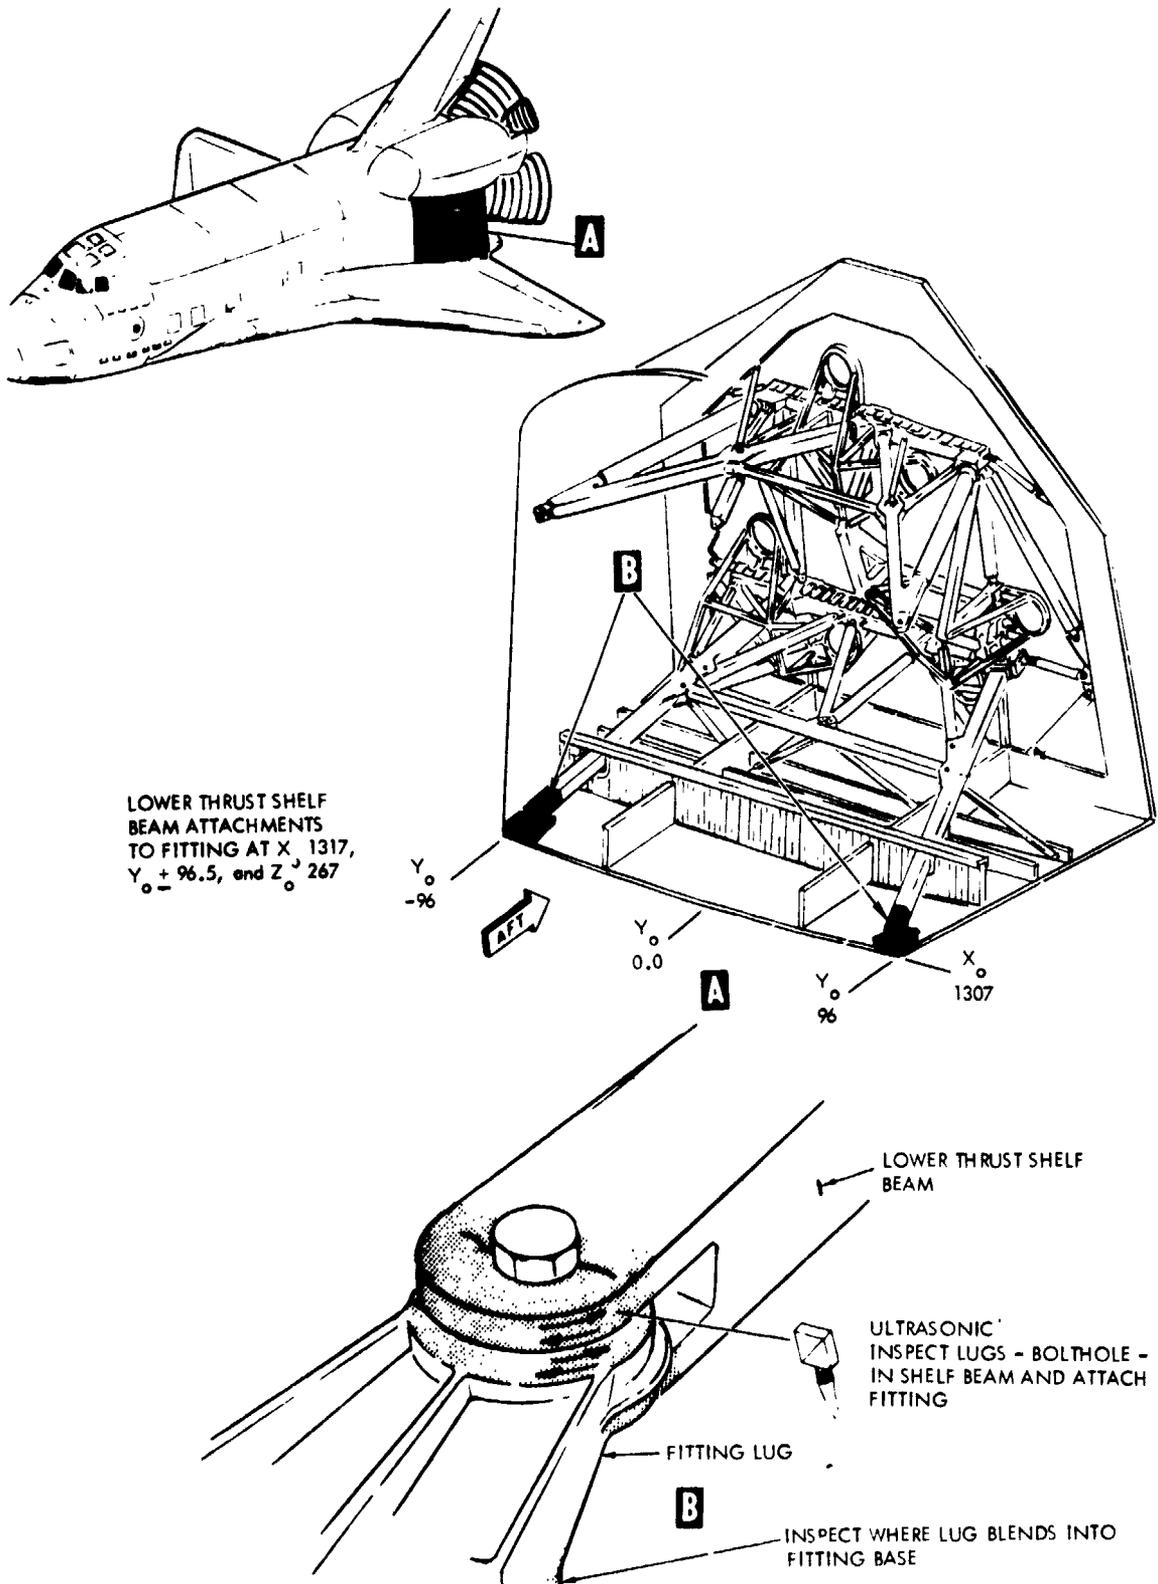
Figure 4-4. Lower Thrust Shelf Attachment to X_o 1307 Bulkhead and Aft Fuselage Floor

DEFECTS: Cracks in clevis bolt holes and fitting attachment areas at the bulkhead.

NDT TECHNIQUES: Primary: Ultrasonic shear wave (para. 1.5.5.3 B) for lug bolt-holes, eddy current surface probe (para. 1.5.4.4) for lug/base fillets.

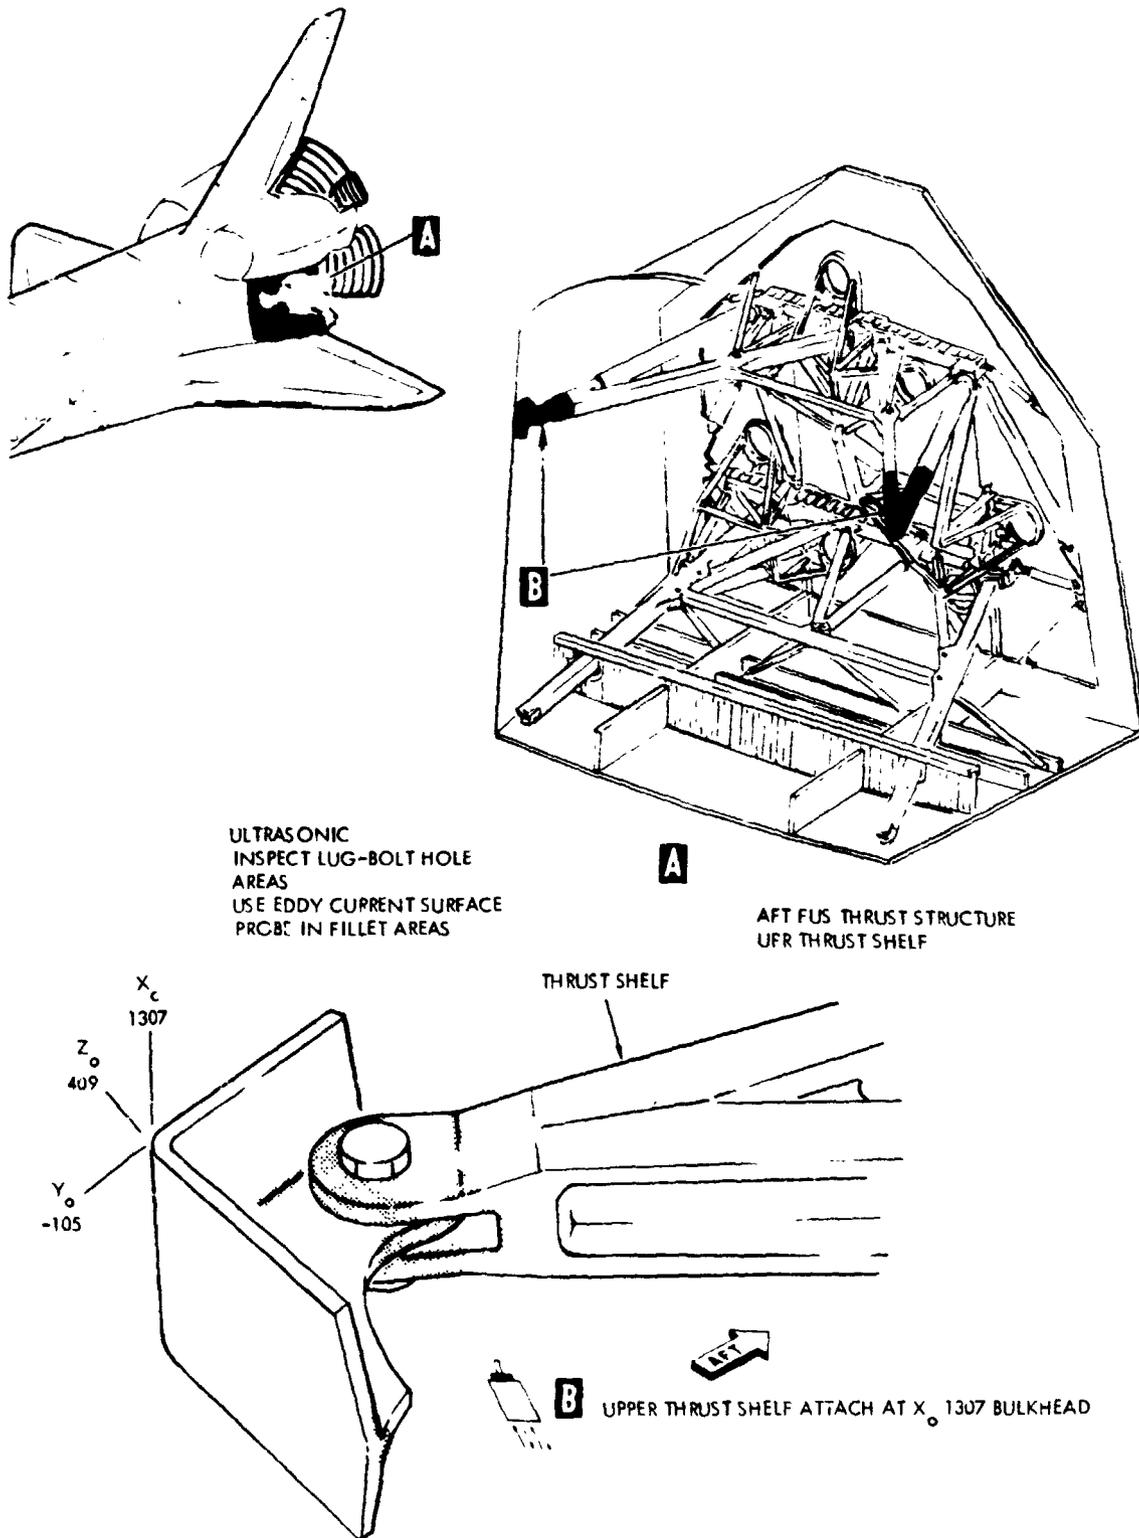
Figure 4-5. Upper Thrust Shelf Attachment to X_c 1307 Bulkhead

DEFECTS: Cracks in the clevis bolt holes in the shelf arm and attach fitting and fitting attachment areas to fwd bulkhead.

NDT TECHNIQUES: Primary: Ultrasonic shear wave (para. 1.5.5.3 B) and eddy current (para. 1.5.4.4) for fillets.

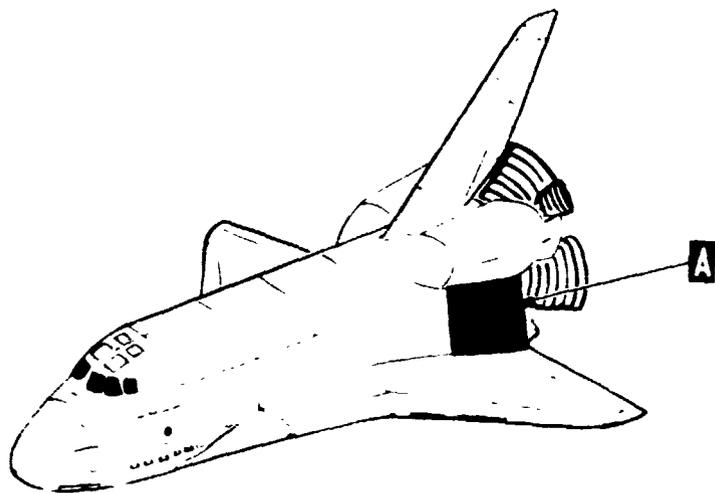
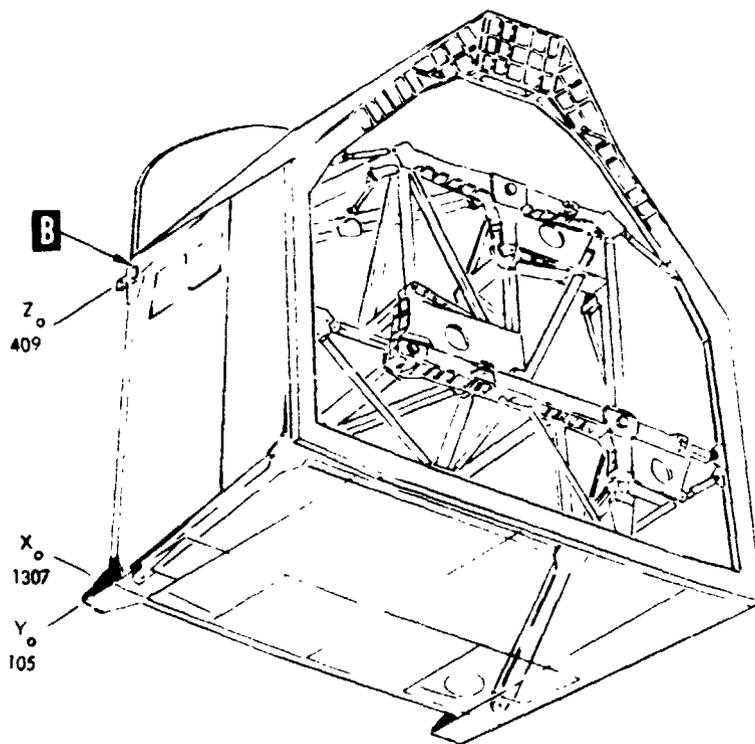
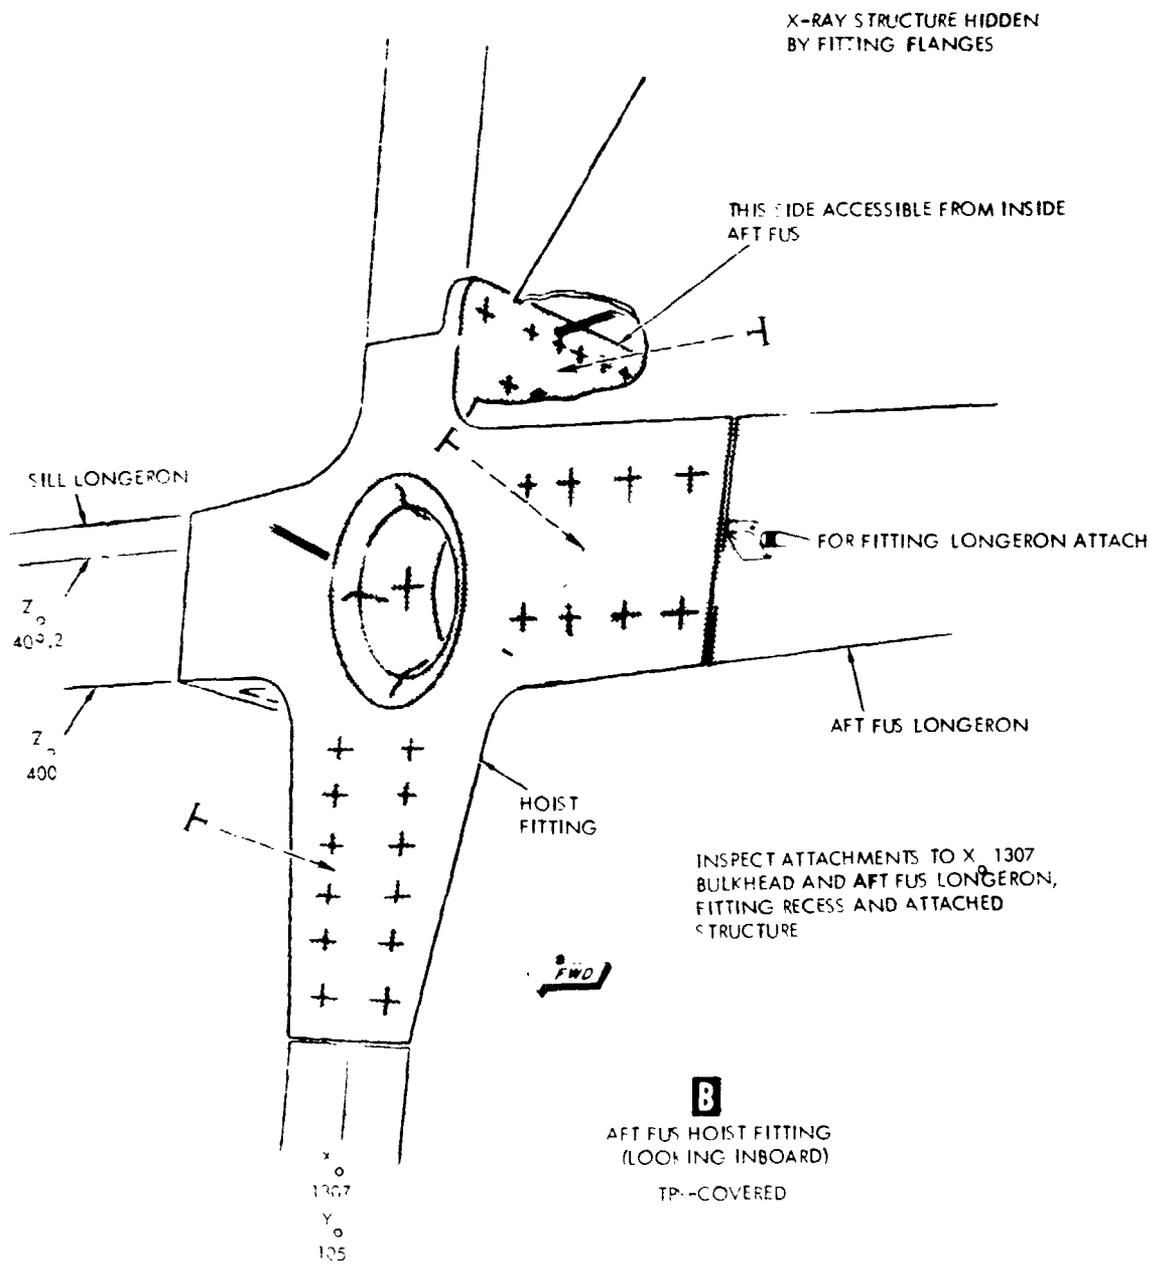
Figure 4-6. Aft Hoist Point (Sheet 1 of 2)

DEFECTS: Cracks may occur around fitting-to-sill longeron splice bolt holes; in fitting attachment holes to $X_{\circ} 1307$ bulkhead and aft-fus side frame; in fillets where bearing housing blends into side flanges.

NDT TECHNIQUES: Primary: Ultrasonic shear wave (para. 1.5.5.3) for bolt holes at fitting to aft fus longeron splice; eddy current for accessible areas; radiography (para. 1.5.6.2) at flange-to-side frame of flange-to- $X_{\circ} 1307$ bulkhead attachment.

AFT FUS HOIST POINT

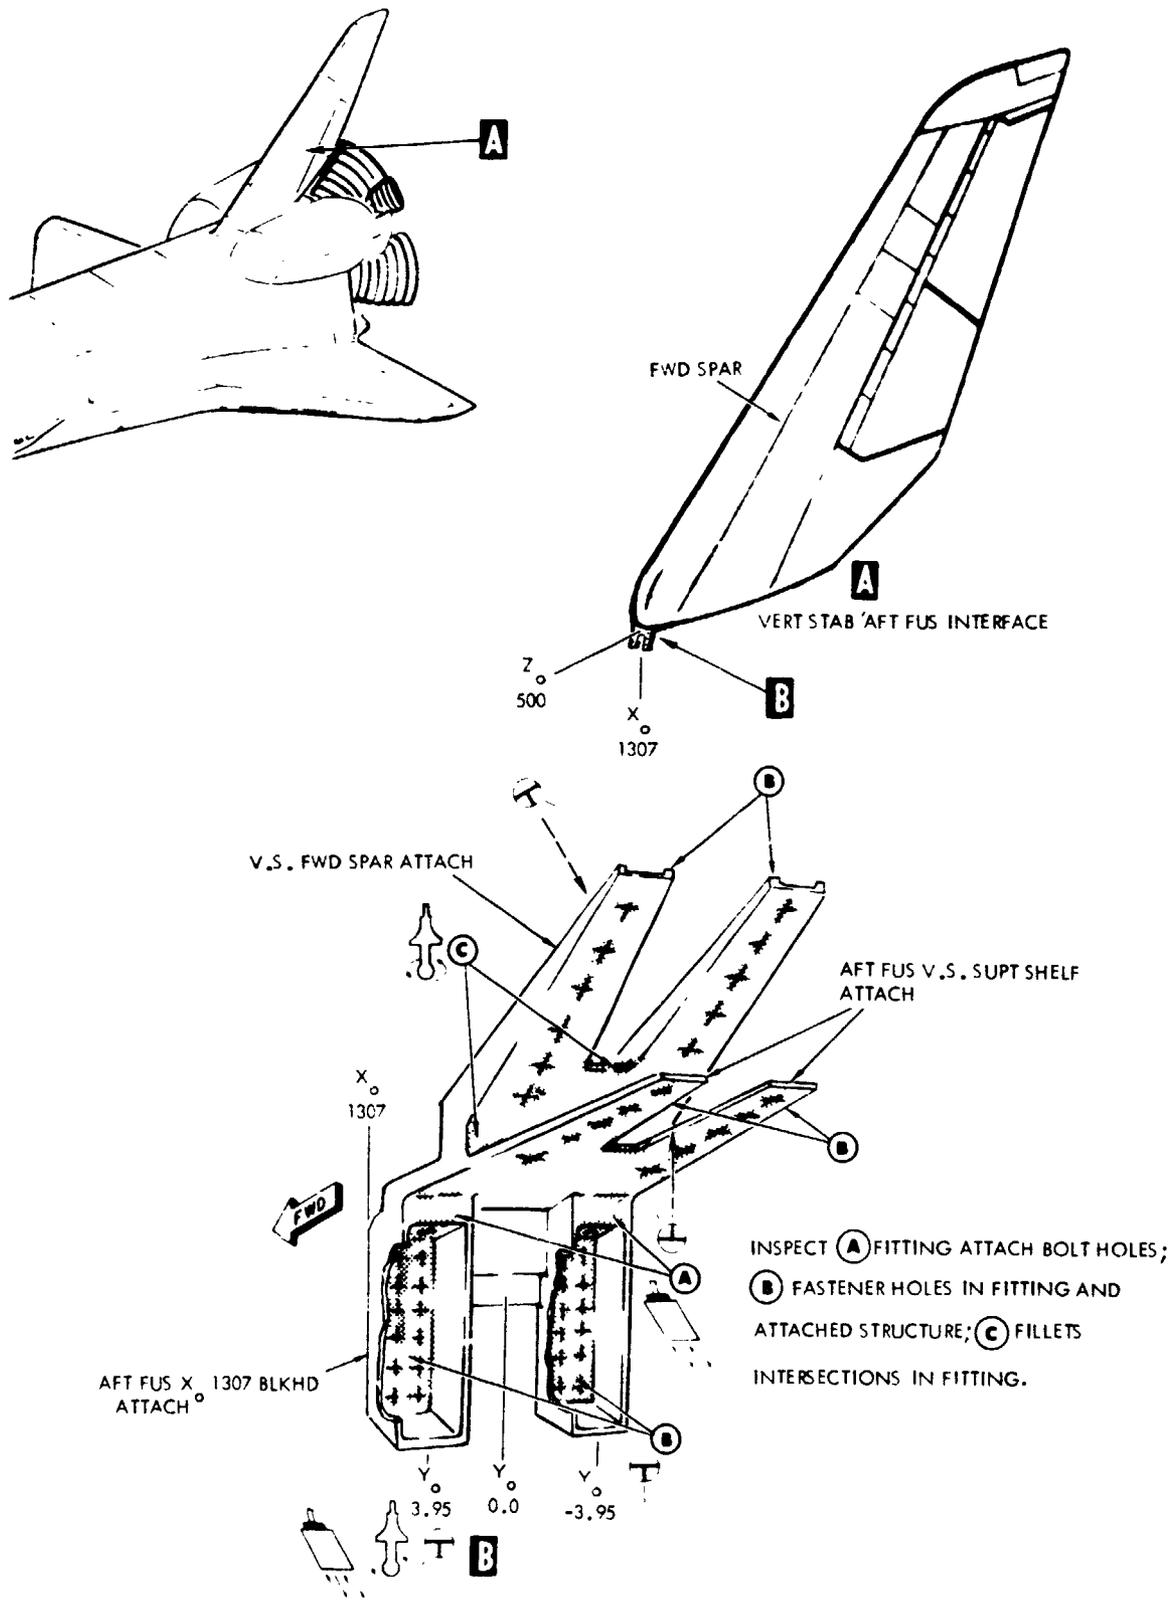
Figure 4-7. Vertical Stabilizer Forward Spar/Fuselage Attach

DEFECTS: Cracks at the two large-diameter bolt holes or at fastener holes at the vertical, horizontal or canted flanges. Cracks may also occur in the fillets where the flanges blend into the base or body of the fitting.

NDT TECHNIQUES: Primary: Radiography (para. 1.5.6.2) for flange inspection, eddy current surface probe (para. 1.5.4.4) for fillet areas; ultrasonic shear wave (para. 1.5.5.3 C) for bolt holes.

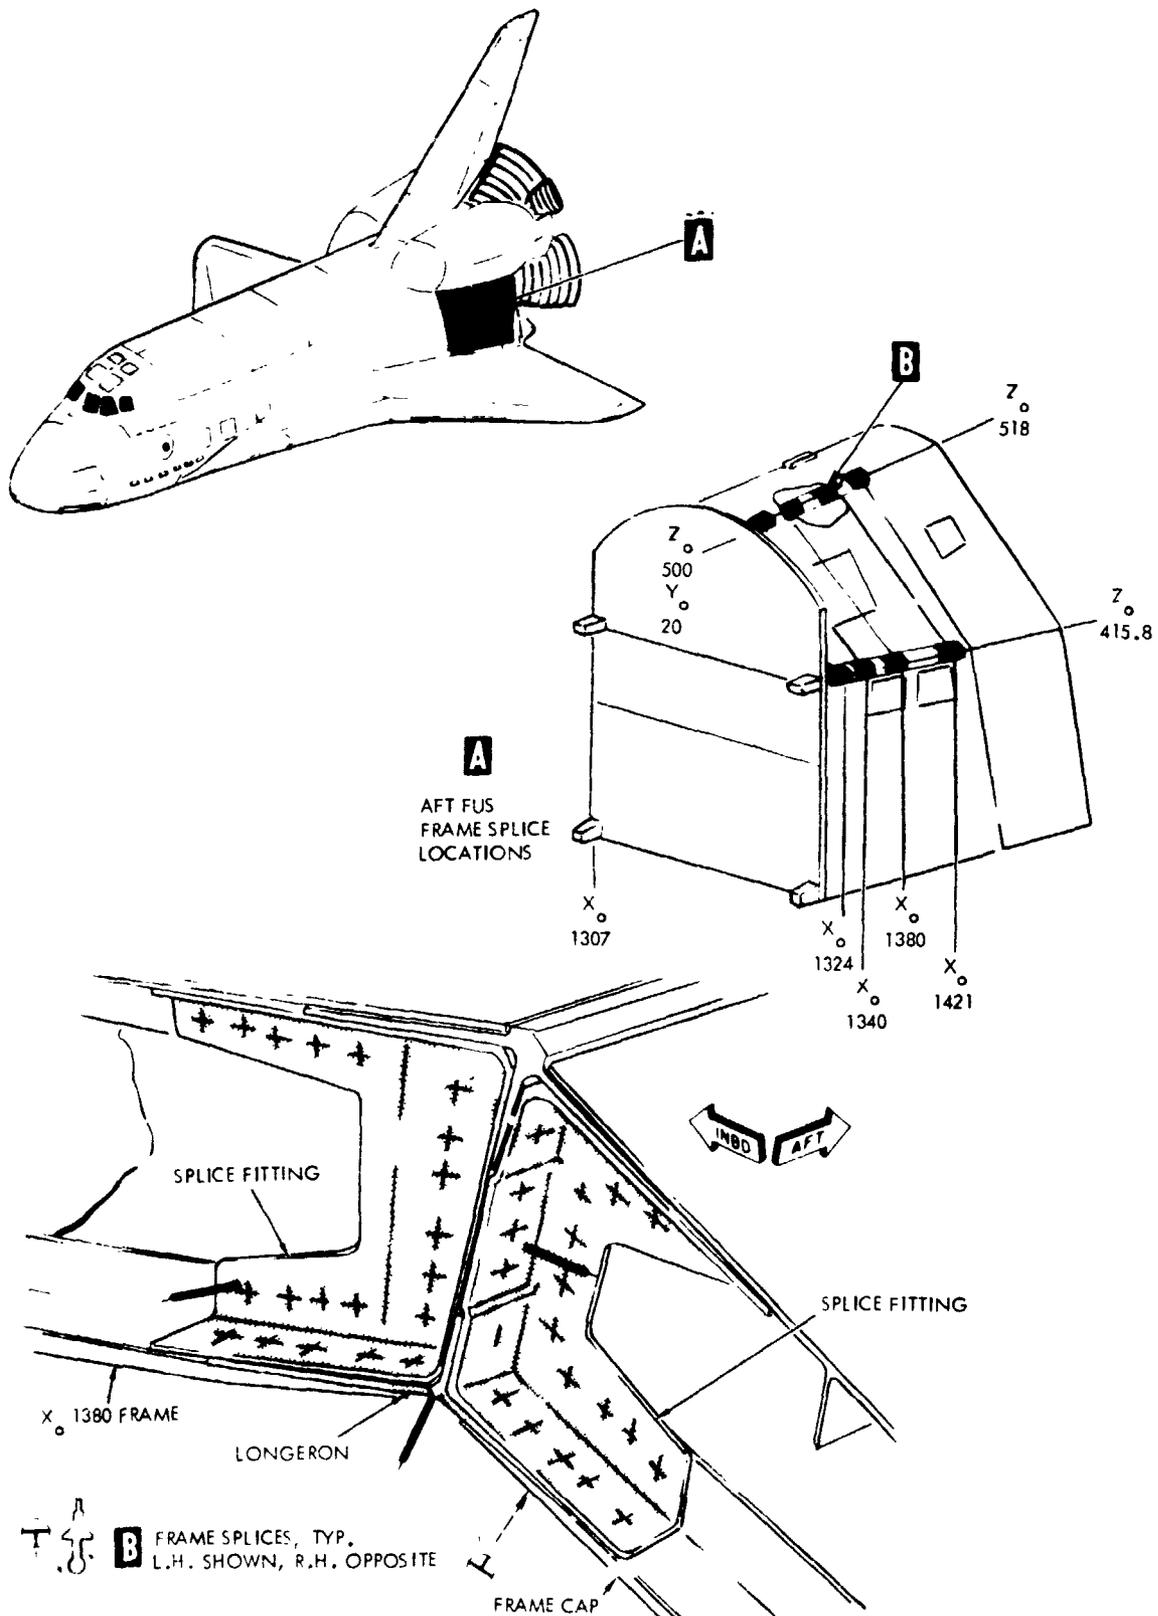
Figure 4-8. Aft Fuselage Frames

COMPONENT/AREA DESCRIPTION: AFT FUSELAGE FRAMES. The aft fuselage frames are built-up structures consisting of inner and outer caps, webs, and reinforcement structures and are made either of 2024-T851 or 2024-T4 aluminum alloy. The frames receive secondary main engine and OMS thrust loads and wind gust loads acting on the vertical fin. An engine-out condition can create adverse load conditions in the aft fuselage structure. The frames should be inspected along the inner caps splice fittings and web attachments, at the splices at the $Z_{\circ} 415$ and $Z_{\circ} 488$ water planes and at $Y_{\circ} \pm 20$ and $Y_{\circ} \pm 105$, respectively. Typical frames are at stations $X_{\circ} 1324$, $X_{\circ} 1340$, $X_{\circ} 1360$ and $X_{\circ} 1400$. The frames have a zinc chromate primer and Supercorapon 515-700 paint surface finish.

DEFECTS: Horizontal cracks radiating from fastener hole in the vicinity of frame splices, in the frame caps, splice fittings, cap-to-web joints.

NDT TECHNIQUES: Primary: Eddy current surface probe (para. 1.5.4.4), radiography (para. 1.5.6.2) for "buried" frame or splice members.

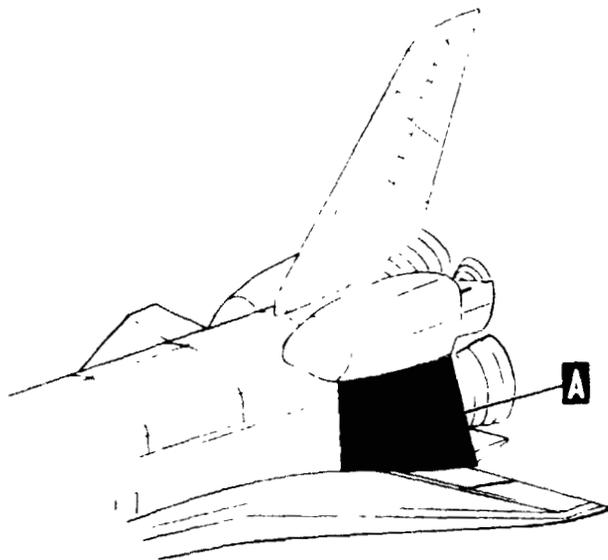
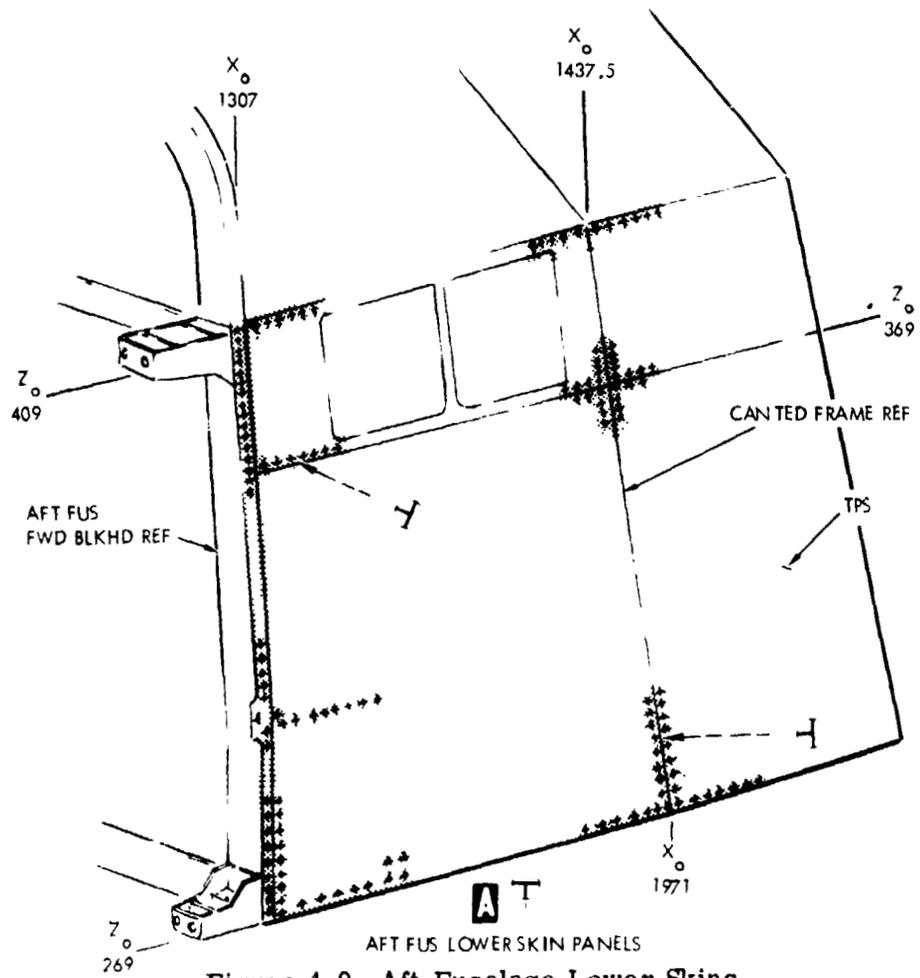
Figure 4-9. Aft Fuselage Lower Skins

COMPONENT/AREA DESCRIPTION: AFT FUSELAGE LOWER SKINS. These skins are integrally stiffened with T-section stringers and are machined from 2124-T851 aluminum alloy plate and have a zinc chromate primer and Super-corapon 515-700 paint surface finish. The outer surface of the skin is protected by LRSI/TPS panels. Load reactions at particular locations may induce fatigue damage in skin fastener holes in these locations.

DEFECTS: Skin cracks emanating from fastener holes or skin panel edges.

NDT TECHNIQUES: Primary: Radiography (para. 1.5.6.2) for all areas outside of wing box area, eddy current surface probe (para. 1.5.4.4) for areas inside wing box (not covered by TPS).

RADIOGRAPHIC INSPECT
SKIN SPLICE AREAS.

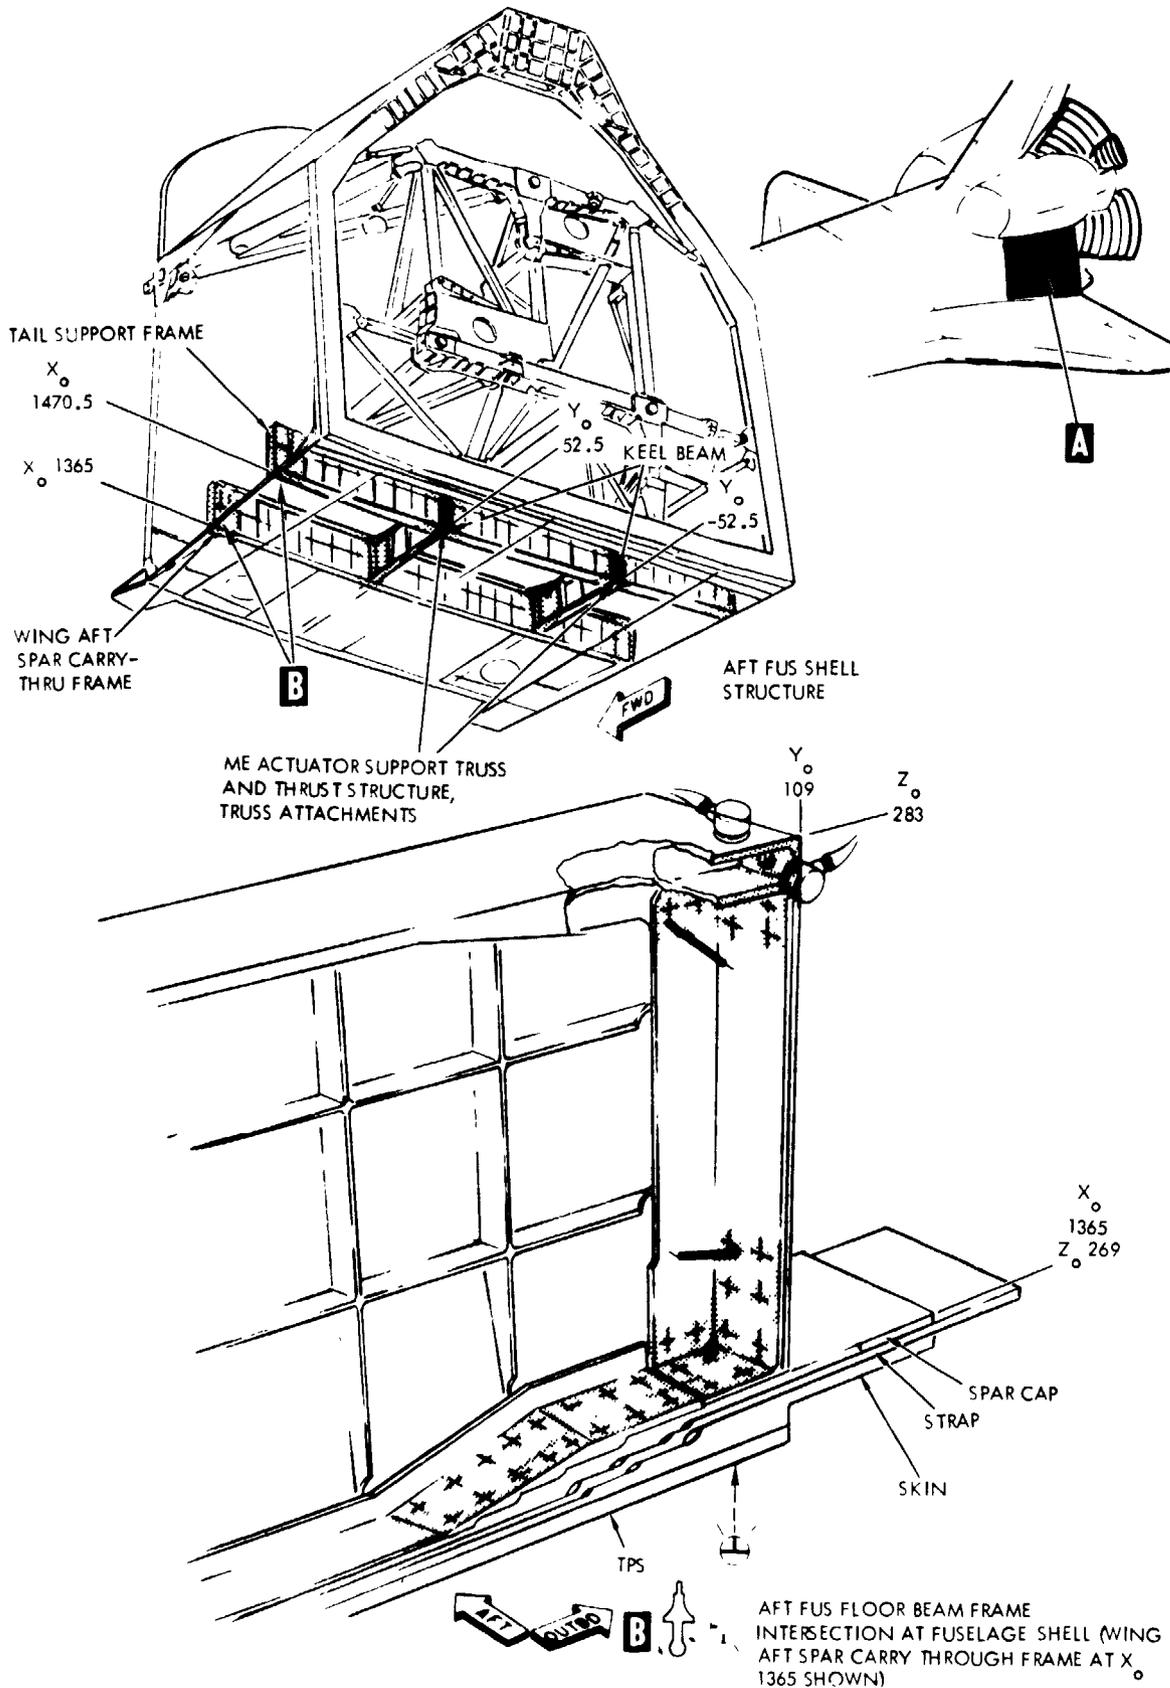
Figure 4-10. Wing Aft Spar Fuselage Carry-Through Frame at X_0 1365 and Floor Beam at X_0 1470

The wing aft spar fuselage carry-through frame, made from 2024-T8511 aluminum alloy extrusions, may experience fatigue damage on the upper and lower caps near the aft-fus sides because of wing flexure, and ET/Orb interaction loads.

DEFECTS: Radial cracks at fastener holes and edge cracks in frame caps in inspection areas of both frames. Radial cracks in lug bolt holes in the thrust truss attach fitting and attachments of this fitting to the X_o 1470 beam.

NDT TECHNIQUES: Primary: Eddy current surface probe (para. 1.5.4.4) for upper cap and fillet areas radiography (para. 1.5.6.2) for bottom caps on X_o 1365 spar near wing aft spar attach area (radiograph spar cap, doubler and skin); ultrasonic longitudinal wave (para. 1.5.5.3 A) for X_o 1365 frame upper cap attach to wing aft spar.
